Manhole Inspection Summary

Manhole # S33AA2008MH

Insp Date: **4/23/07 9:37 AM**

Location Address: **203 TAPLOW RD**

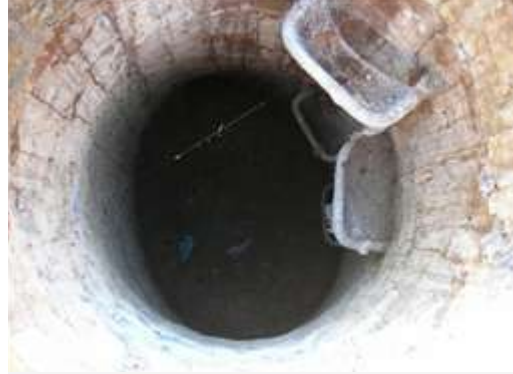
Top View

Channel Material: **Brick** ☐ Parged ☒ **Debris** (not Condition related)

Channel debris.

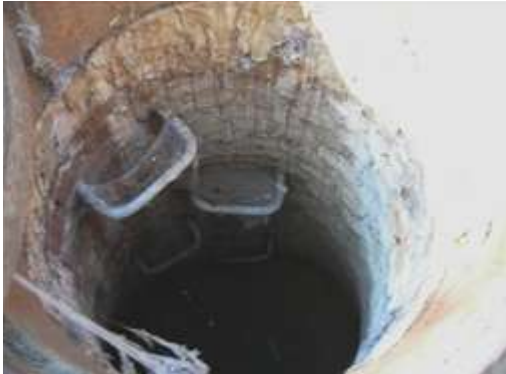
Defect

Frame Offset: **0** (in.) Condition: ☐ Sound ☐ Cracked ☒ **Leaks**

Infiltration: ☐ None ☒ **Joint** ☐ Cracks ☐ Mortar ☐ Roots ☐ Wall

Frame leaks. Adjustment infiltration.

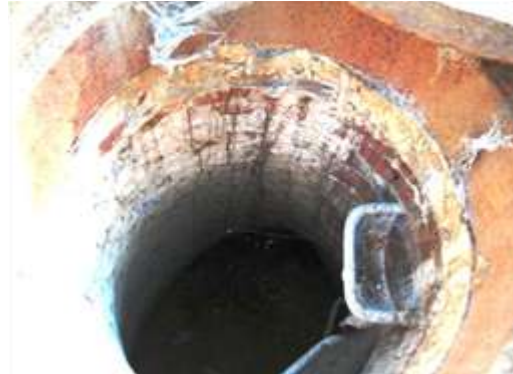
Defect

Frame leaks. Adjustment infiltration - other side.

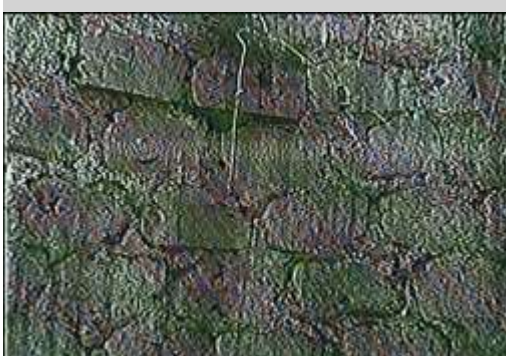
Defect

Condition: ☐ Sound ☐ Cracked ☐ Root Intrusion ☐ Loose Brick ☒ **Deteriorated**

Infiltration: ☐ None ☐ Joint ☐ Cracks ☒ **Mortar** ☐ Roots ☐ Wall

Corbel deterioration and infiltration.
